SUPER STUD BUILDING PRODUCTS

ASTM E455 Floor Diaphragm Test on a
10' x 20' Floor using 3/4" DragonBoard Structural Subflooring
Fastened at 6" & 12" to 16 ga. Steel Framing Spaced 24" o.c.

2019-6211

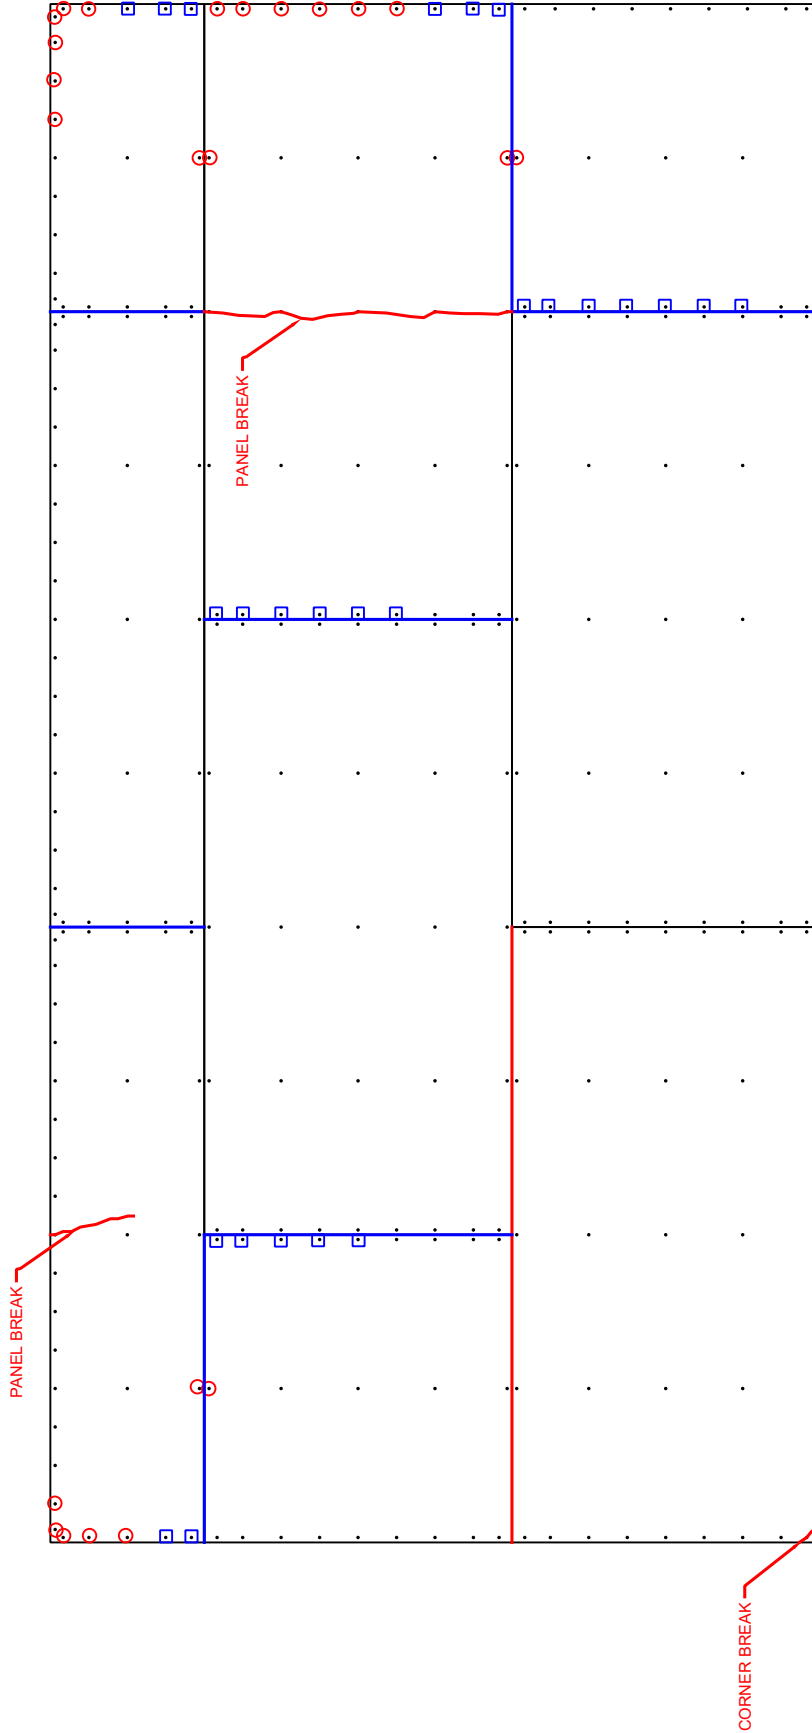
DOWN BY: J. HOLDEMAN	REVISED ON:	CLIENT:	SUPER STUD
DATE: 8/2/19			
SCALE:			
JOB NO. 2019-6211		TITLE:	CONFIGURATION 19-6211-1
DWG. NO. B1

Failure: **Row #1**, Joist #2 - Fastener rotation at T&G, Joist #3 - Butt-joint separation >3/4" with edge breakout @ 7 fasteners on 4' sheets, Joist #7 - ~1/2" Butt-joint separation with edge breakout @ four (4) locations. T&G 1-2 shifted 1/2" from Joist #7 to #11 with fastener rotation @ T&G on Row #1 side. Rolled end joist at T&G. **Row #2**, Joist #1 - Panel break out @ four (4) fasteners and fastener rotation @ five (5) locations. Joist #3 - panel split broke thru the fastener locations from T&G 1-2 to T&G 2-3, Joist #5 - ~1/2" butt-joint separation with edge breakout @ six (6) locations, Joist #9 - ~3/8" separation of butt-joint with edge breakout @ five (5) locations, Joist #11 - Edge breakout @ three (3) locations from T&G 1-2. **Row #3**, Joist #1 - Edge breakout @ three (3) locations and fastener rotation along bearing track corner @ seven (7) locations, Joist #3 - Butt-joint separation ~1/4", Joist #9 - Panel cracked from Rim Track to center fastener ~1-1/2" from screw, Joist #11 - Edge breakout @ two (2) locations and fastener rotation @ three (3) locations with two (2) locations at rim track corner.

- ◇ = SHEATHING FRACTURES @ FASTENERS
- XXX = SURFACE SPALLING
- = FASTENER ROTATION
- = SHEATHING PULL-OVER / BREAKOUT
- △ = FASTENER SHEAR
- (blue) = SEPARATION OR SHIFTING (>1/4")
- (red) = SEPARATION OR SHIFTING (<1/4")

Notes: Butt-joint separation started at approximately 10,000 lbf.

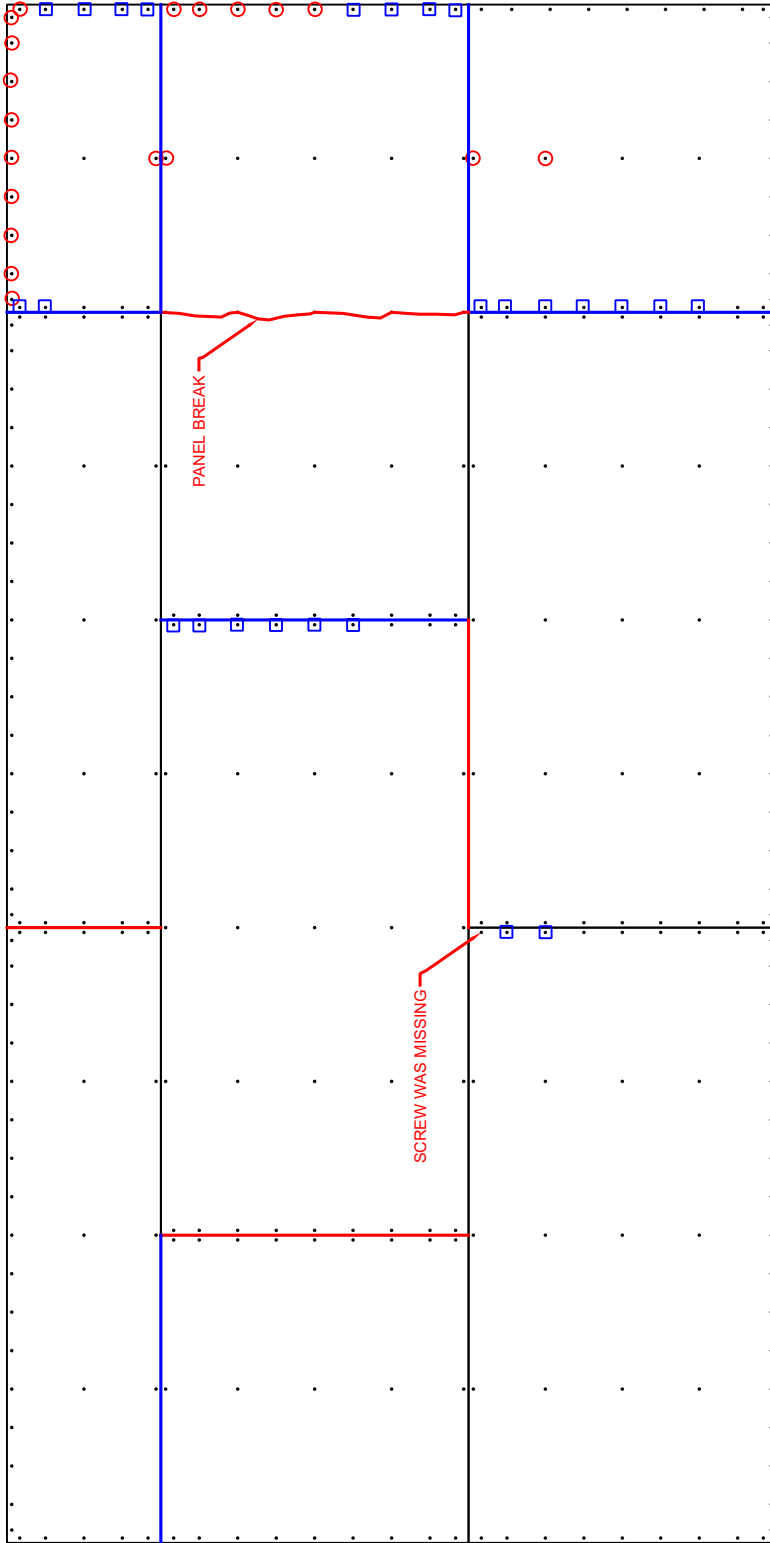
DWN BY: J. HOLDEMAN	REVISED ON:	CLIENT:
DATE: 8/2/19		SUPER STUD
SCALE:		CONFIGURATION
JOB NO.: 2019-6211		19-6211-2
DWG. NO.: B2

Failure: Row #1, Joist #2 - Fastener rotation at T&G, Joist #3 - Butt-joint separation >1/2" with edge breakout @ 7 fasteners on 4' panel, Joist #7 - ~3/8" Butt-joint separation with edge breakout @ two (2) locations. Row #2, Joist #1 - Panel break out @ four (4) fasteners and fastener rotation @ five (5) locations. Joist #3 - panel split broke thru the fastener locations from T&G 1-2 to T&G 2-3, Joist #5 - ~1/2" butt-joint separation with edge breakout @ six (6) locations. Row #3, Joist #1 - Edge breakout @ four (4) locations and fastener rotation along bearing track corner @ nine (9) locations, Joist #3 - Butt-joint separation ~1/4", Joist #9 - Panel cracked from Rim Track to center fastener ~1-1/2" from screw, Joist #11 - Edge breakout @ three (3) locations.

- ◇ = SHEATHING FRACTURES @ FASTENERS
- ⊗ = SURFACE SPALLING
- = FASTENER ROTATION
- = SHEATHING PULL-OVER / BREAKOUT
- △ = FASTENER SHEAR
- (Blue) = SEPARATION OR SHIFTING (>1/4")
- (Red) = SEPARATION OR SHIFTING (<1/4")

Notes: Butt-joint separation started at approximately 10,000 lbf.

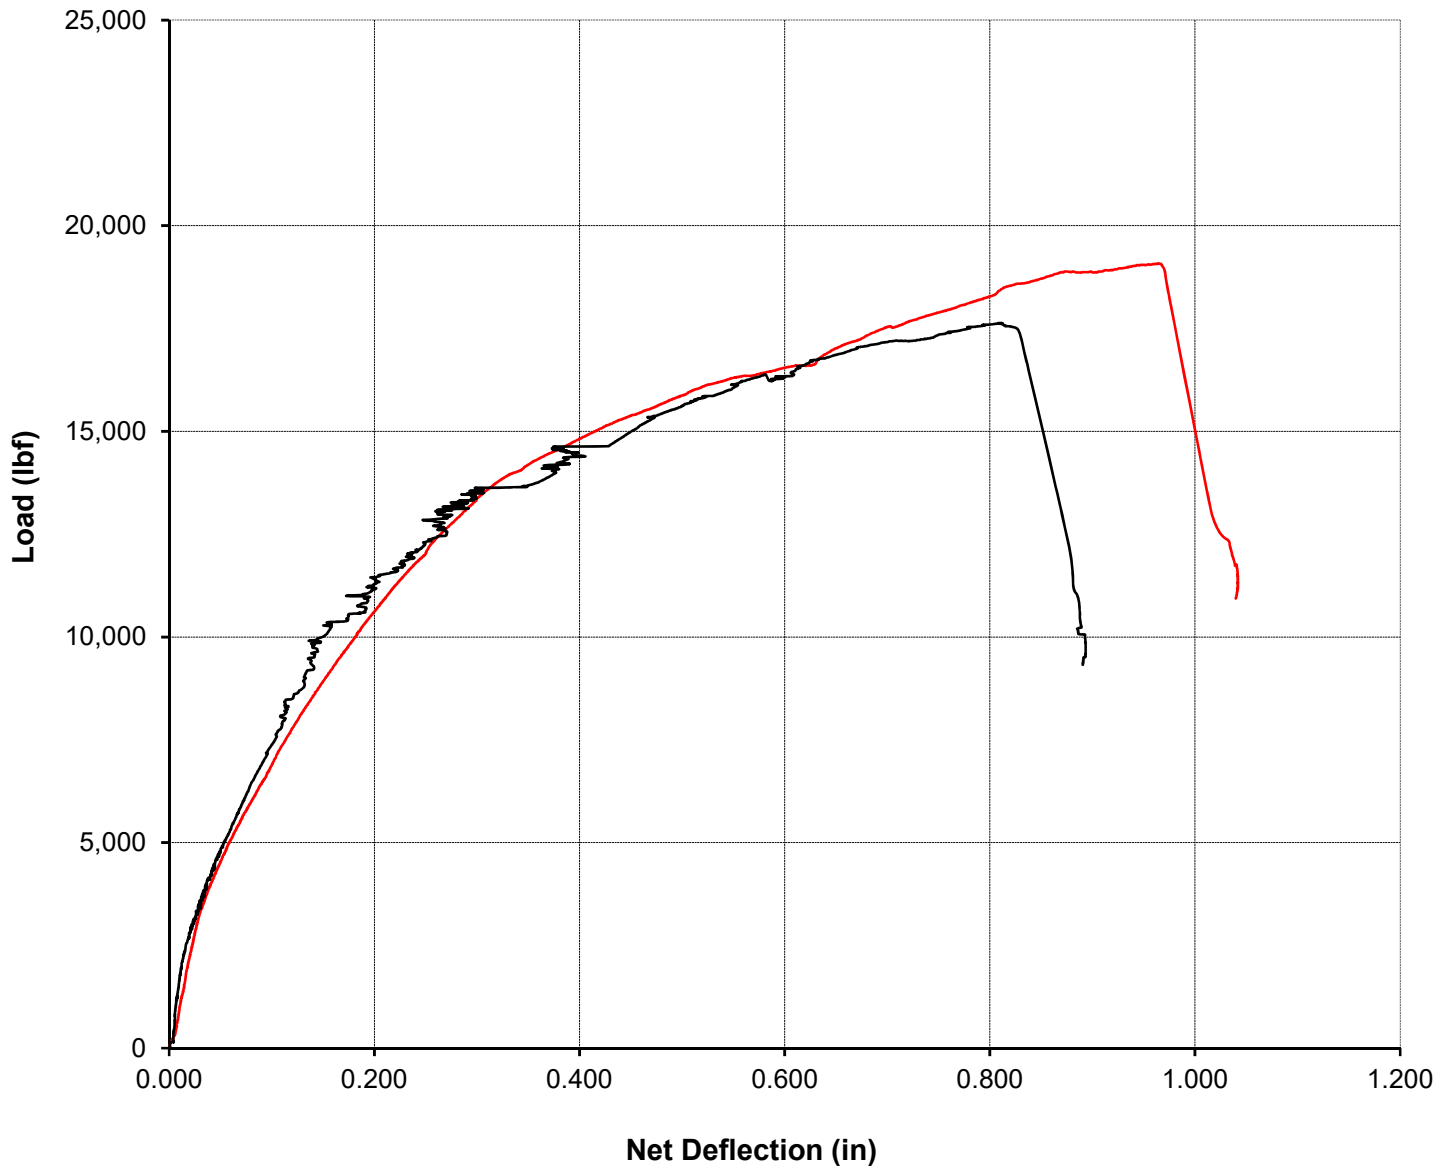
**Super Stud
ASTM E455 Simple Beam Floor Diaphragm Test
using 3/4" Dragon Board
with a 6"-12" Fastening Schedule to 24" o.c. 16 ga. Framing**

— 19-6211-6/12@24oc-1

— 19-6211-6/12@24oc-2

See the attached data pages and charts for test results.

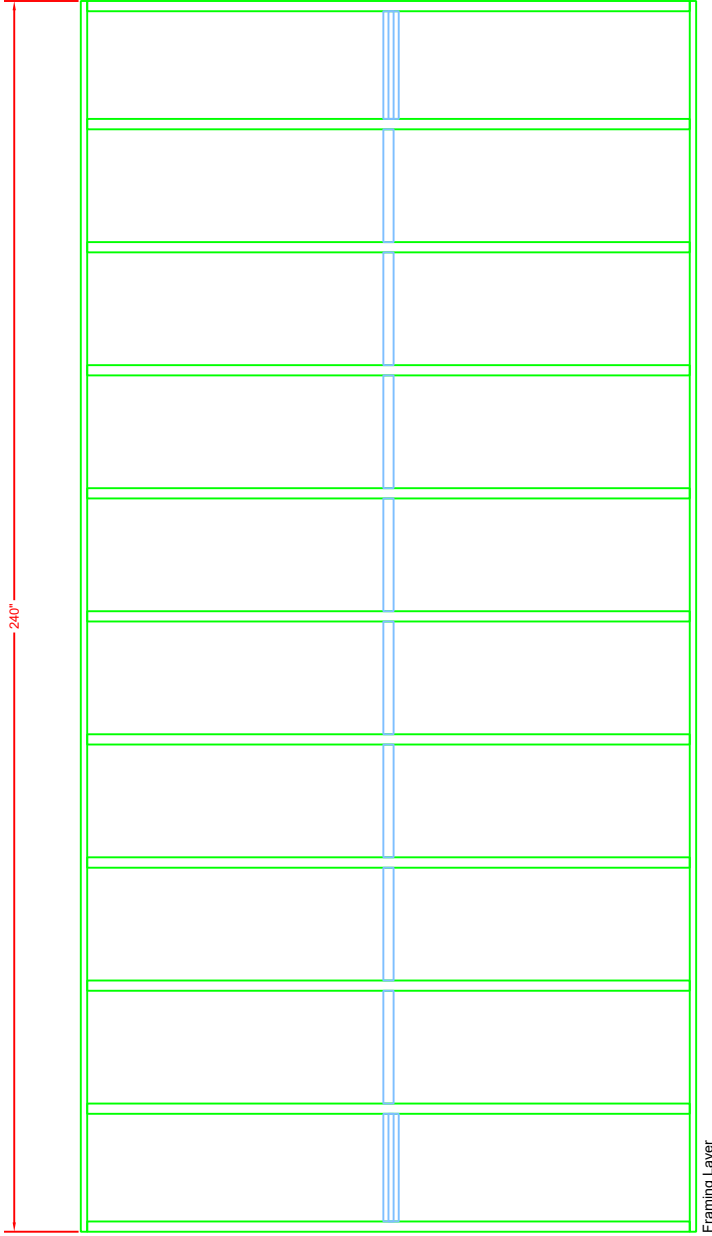
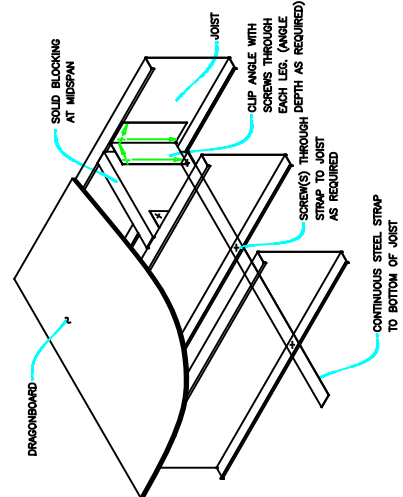
DWN. BY: J. HOLDEMAN	CLIENT: SUPER STUD
DATE: 8/2/19	REVISED ON:
SCALE:	TITLE: FRAME DETAILS
JOB NO. 2019-6211	DWG. NO. B3

- A. The joists were attached to the track using three (3) hex head #10-16 x 3/4" lg. Drivall screws into the side of the joist through 8" long clip angles fastened to the rim track at 24" o.c. using three (3) hex head #10-16 x 3/4" lg. Drivall screws. A 16 ga. strap, 4" wide, was attached to the bottom of the joists with a single screw along the center of the floor to prevent joist rotation.

- C. A 1/4" x 4" x 4" steel angle iron was then fastened to the end joists flush to the bottom of the joists to minimize crumpling of the joists at the bearings and to represent the top plate member. See attached drawings and photographs for details.

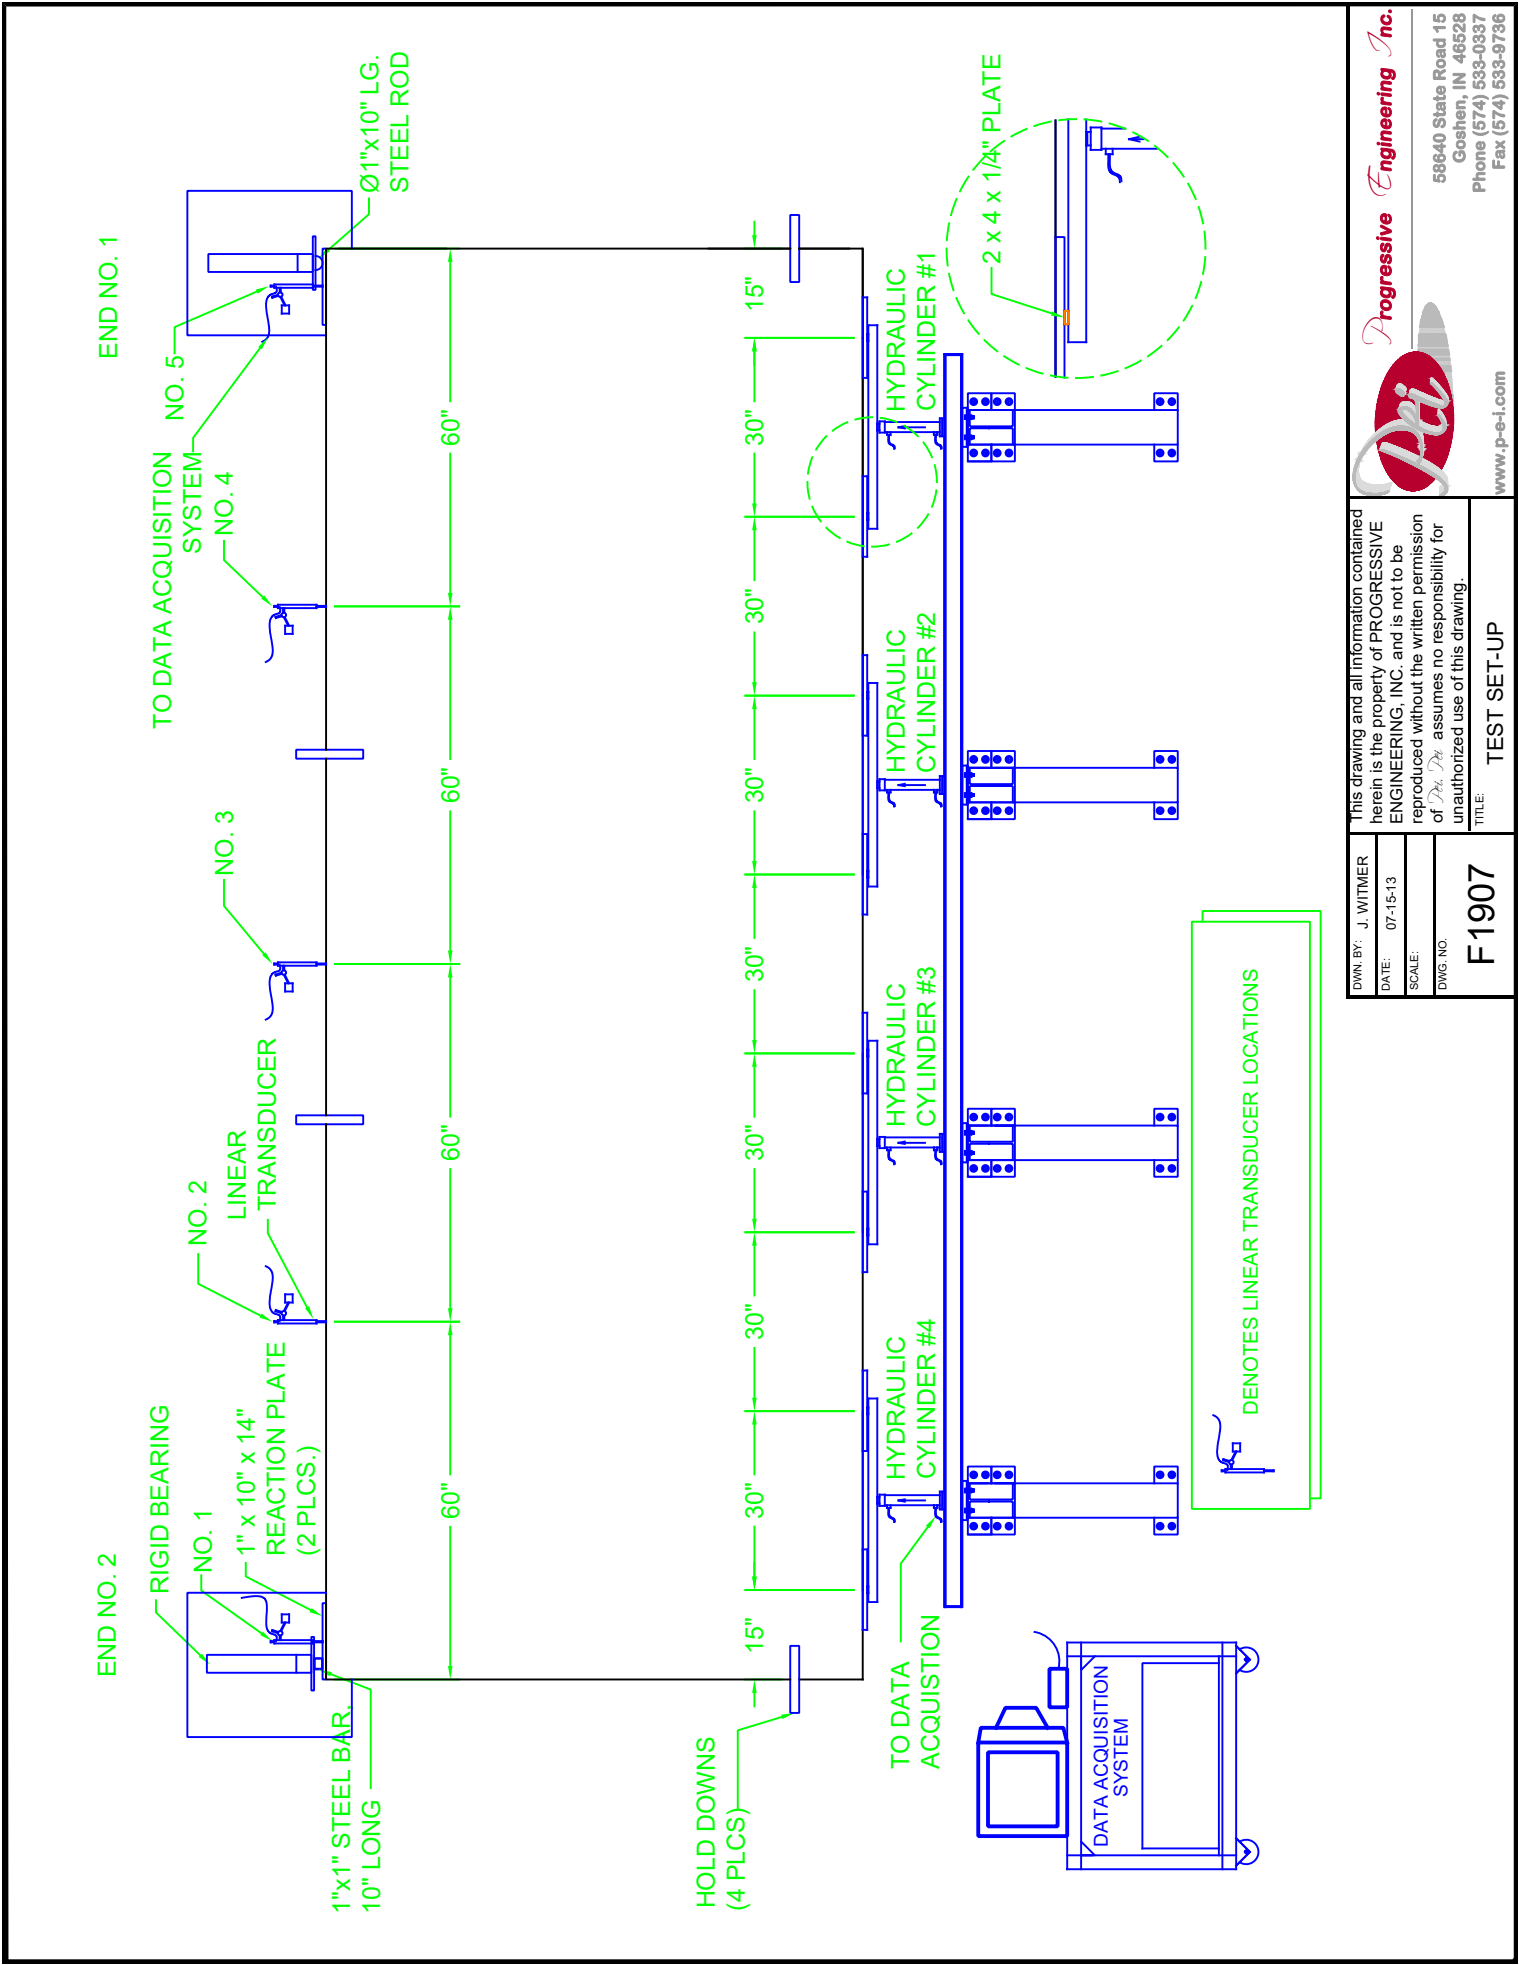
The test sample was supported by appliance rollers at 48" o.c. around the perimeter of the test sample on a concrete floor. A bearing support was placed at both ends of the test sample. A 1" thick x 10" tall x 14" wide reaction plate was set against the rim track at each bearing to minimize local deformation. The reaction plates were spaced away from the bearing with a 2" dia. half-round steel rod on both ends. Four (4) loading cylinders were located on the opposite side of the test sample. The load was applied from the cylinders to two (2) 18" loading blocks that were connected with steel tubes to uniformly apply the load to the floor. Four (4) linear transducers and one (1) string pot, were placed along the bearing side of the test sample to measure deflection. See attached fixture drawing no. F1907, and F1908 for details.

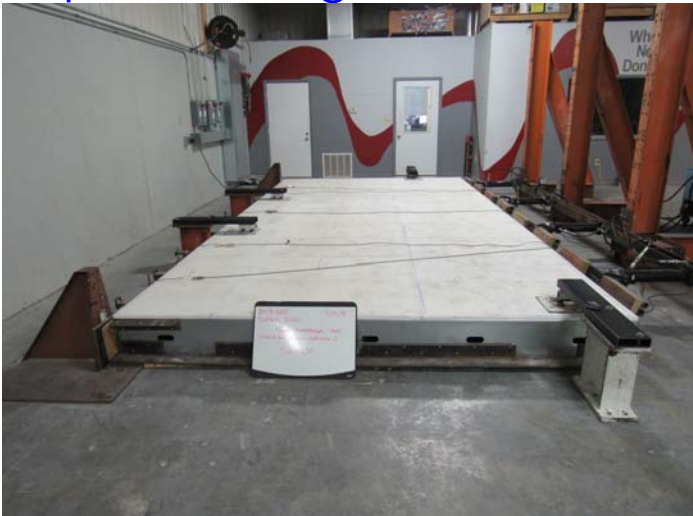
Test Setup

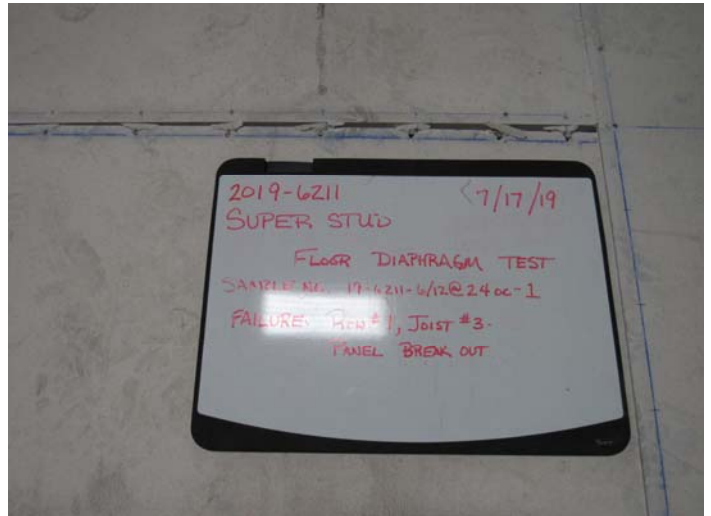
Separation Between Panels (Row 1 Joist 3)

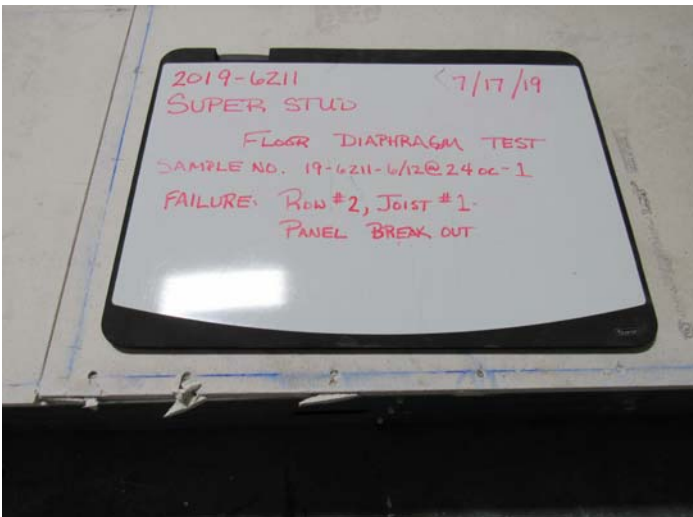
Panel Breakout (Row 2 Joist 1)

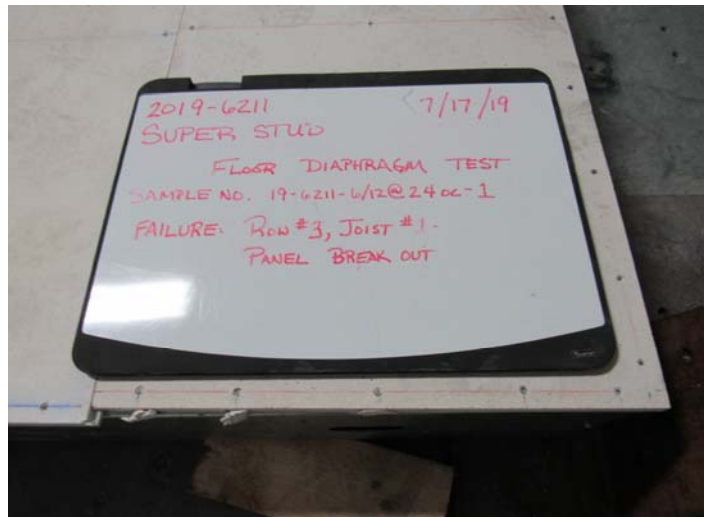
Panel Breakout (Row 3 Joist 1)

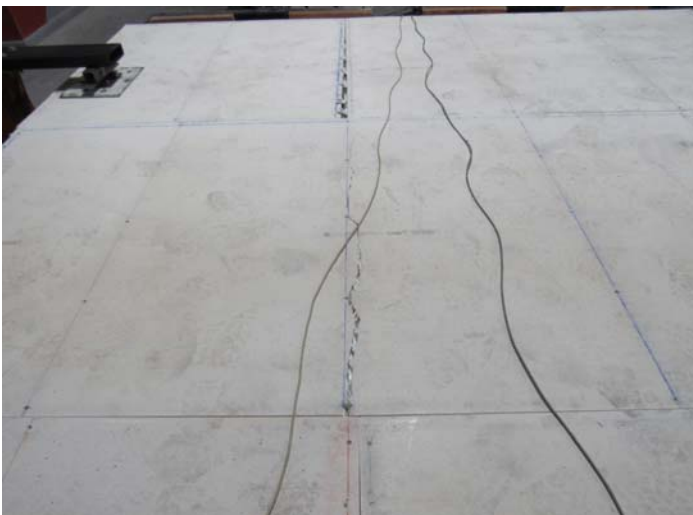
Panel Break/Split (Row 2 Joist 3)

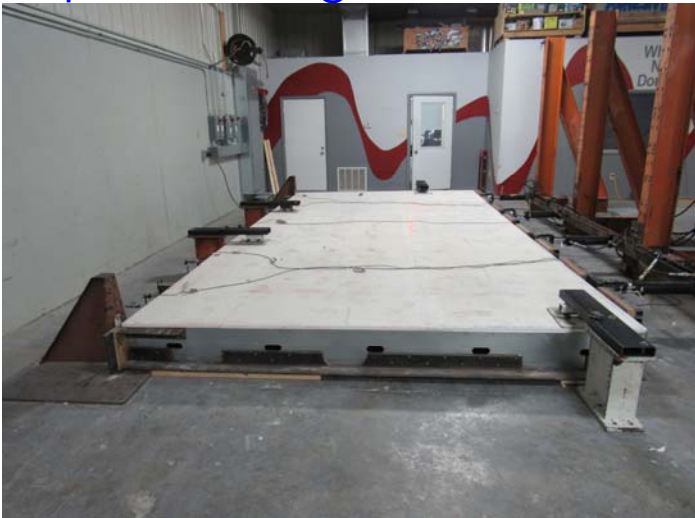
Test Setup

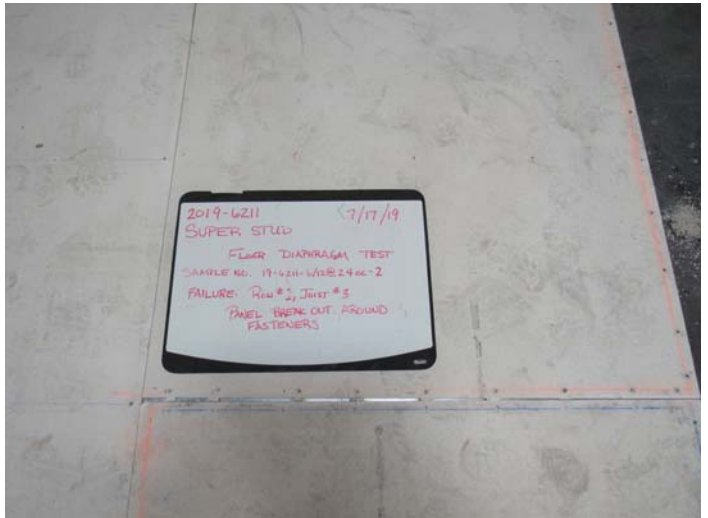
Separation Between Panels (Row 1 Joist 3)

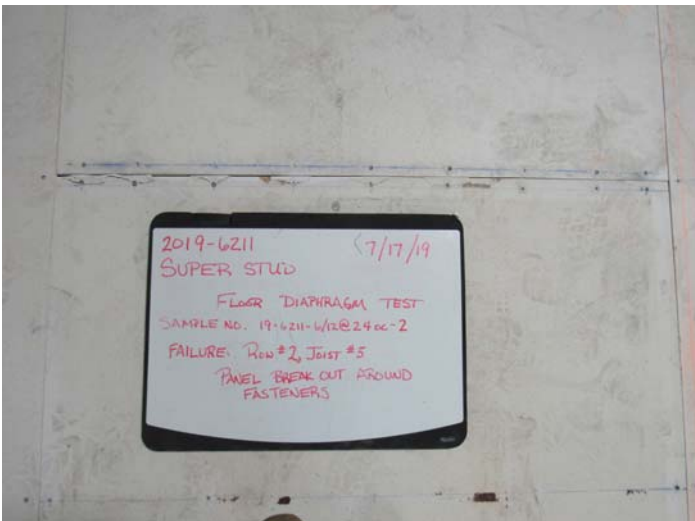
Separation Between Panels (Row 2 Joist 5)

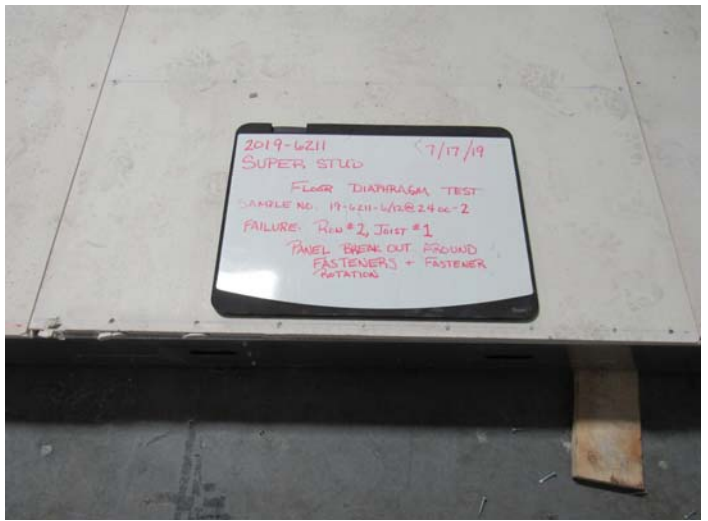
Panel Breakout (Row 2 Joist 1)

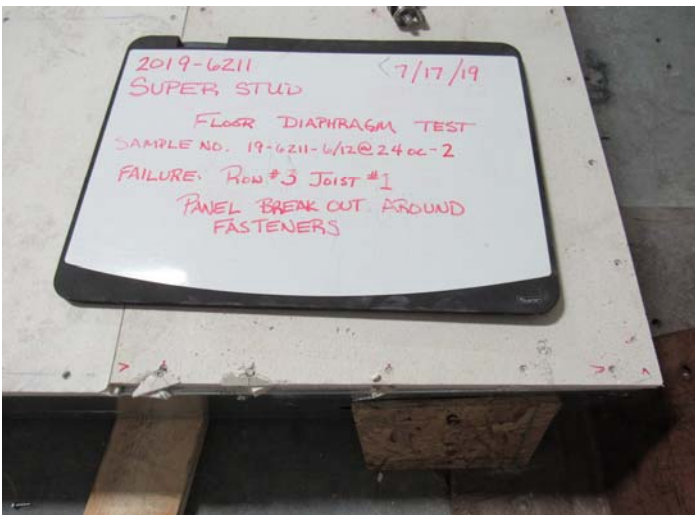
Panel Breakout (Row 3 Joist 1)

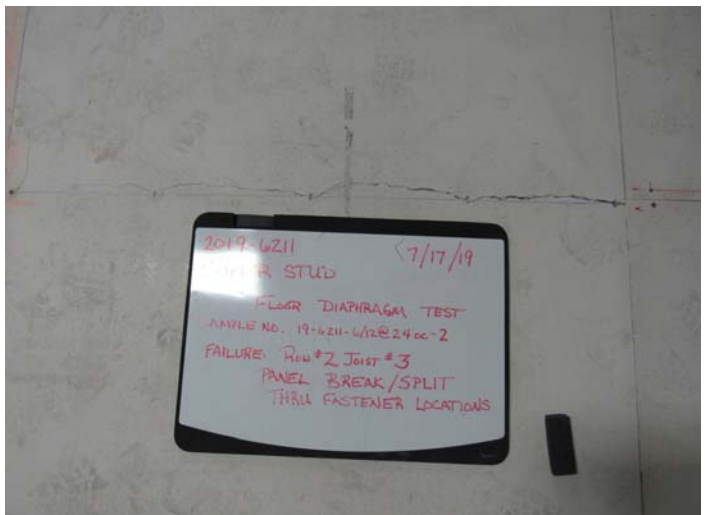
Panel Break/Split (Row 2 Joist 3)

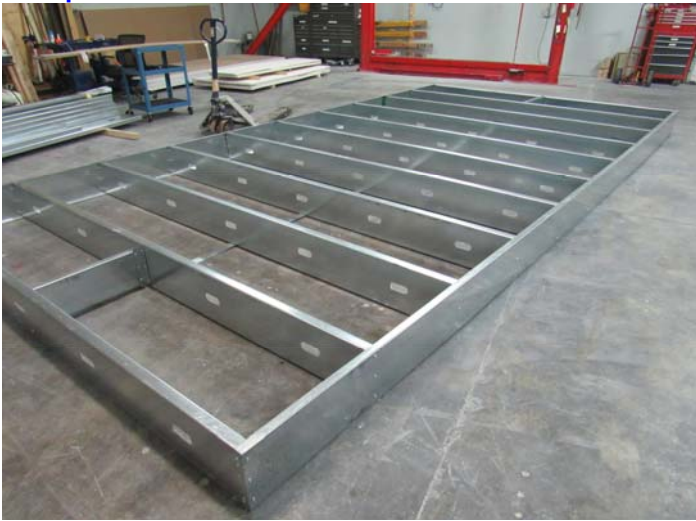
Test Frame

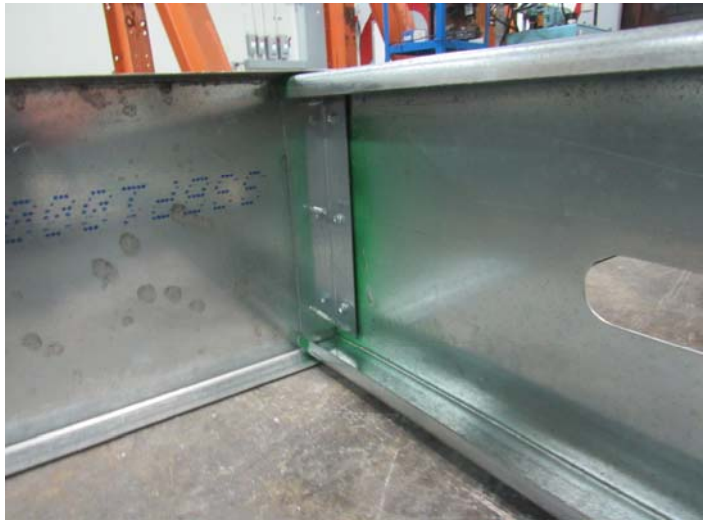
Joist to Track Connection

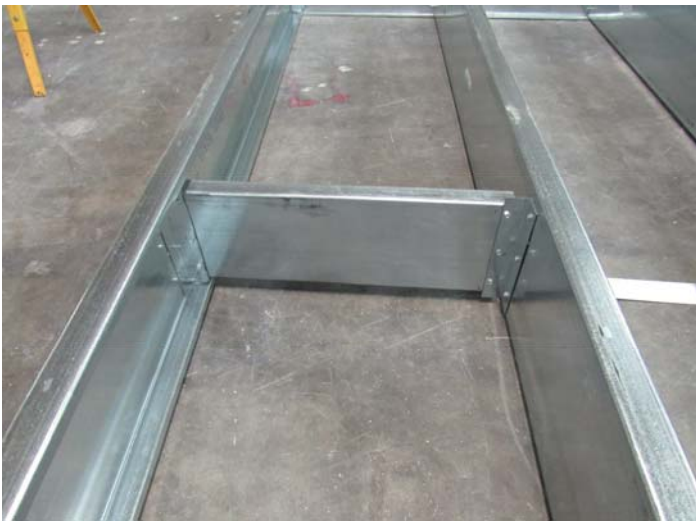
End Blocking Connection

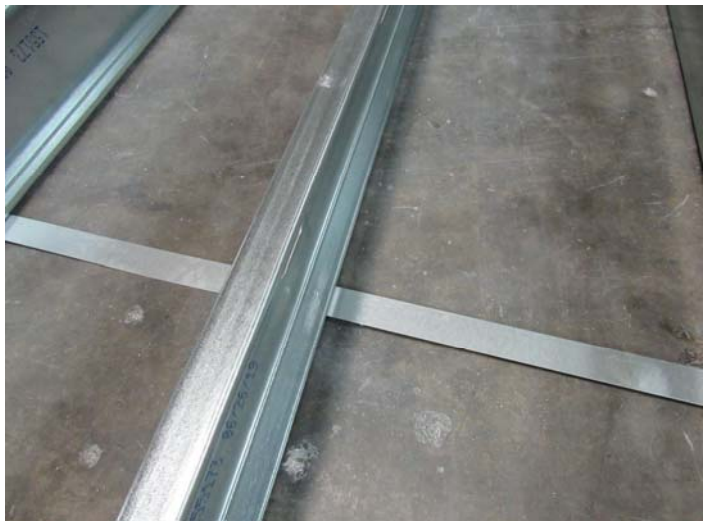
Strap Bracing Connection

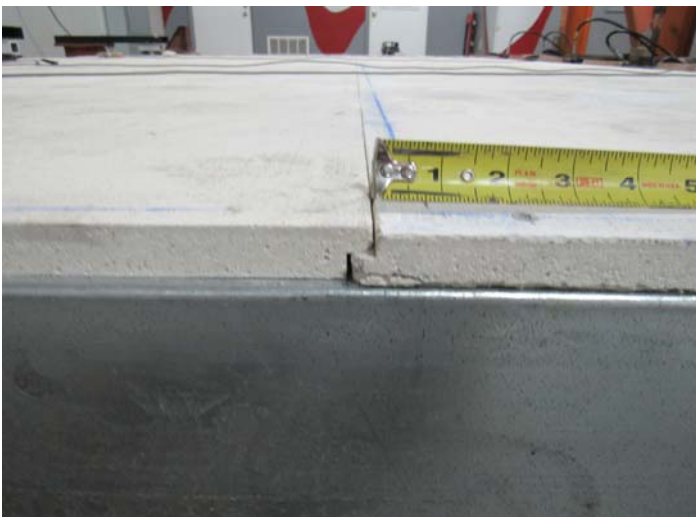
Sheathing Fastener Edge Distance and Shiplap

- B. The frame was squared and then the 3/4" DragonBoard Structural Subflooring Panels were fastened to it. The panels were fastened at 6" o.c. around the perimeter, inset 2" from the corners, and 12" o.c. in the field with #8 screws. Fasteners were inset 3/4" from all panel edges and ends. Care was taken to insure that the fasteners were kept flush or slightly below the surface of the panels and also did not strip out in the steel framing. See attached drawings for details.

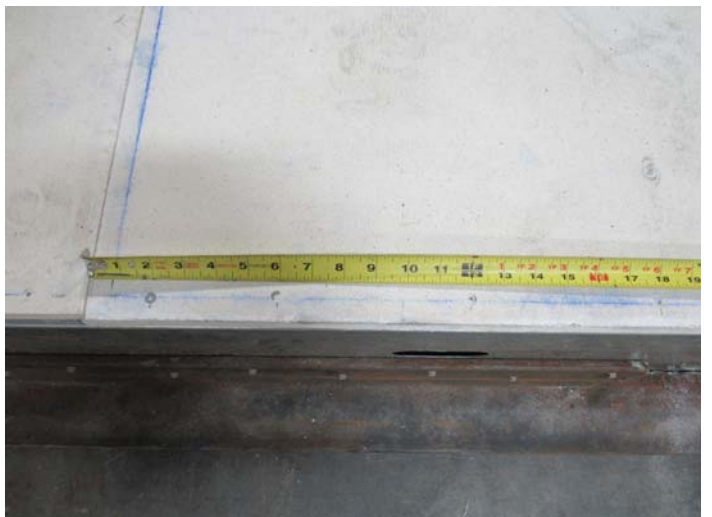
Sheathing Fastener Spacing
